Final Programmatic Report

Project Name and Number: Reef Saving Mooring Buoy System Management (FL) #2007-0083-002

Recipient Organization: Broward County Natural Resources Planning and Management Division

Date Submitted: April 8, 2009

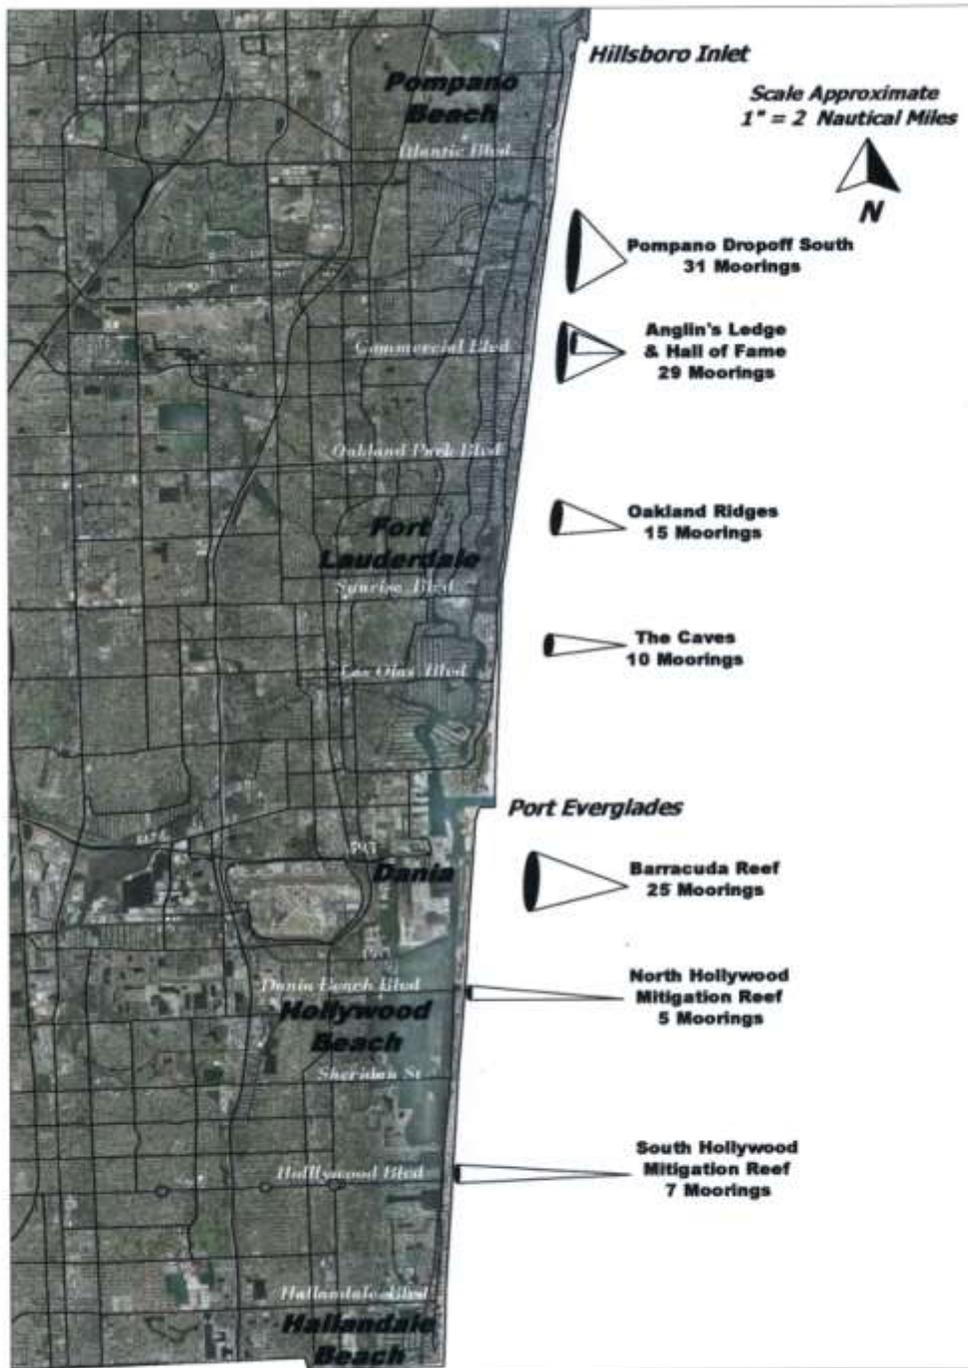
Figure 1: Location of Broward County mooring buoys at the beginning of the project.

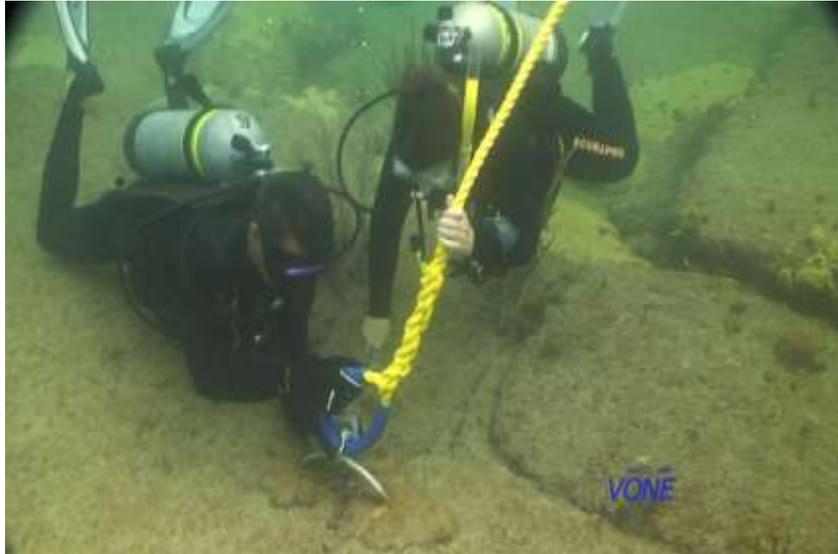
Figure 4: Volunteers from Vone Research, Inc. attaching a new mooring buoy to an anchor.

The new mooring buoys were installed at Suzanne's Ledge between June 19 and June 21, 2008 (Figure 4). Immediately upon installation, boaters began using the new buoys (Figure 5). Personal communications with a local dive operator and Vone Research, Inc. report heavy use of the buoys, especially on the weekends

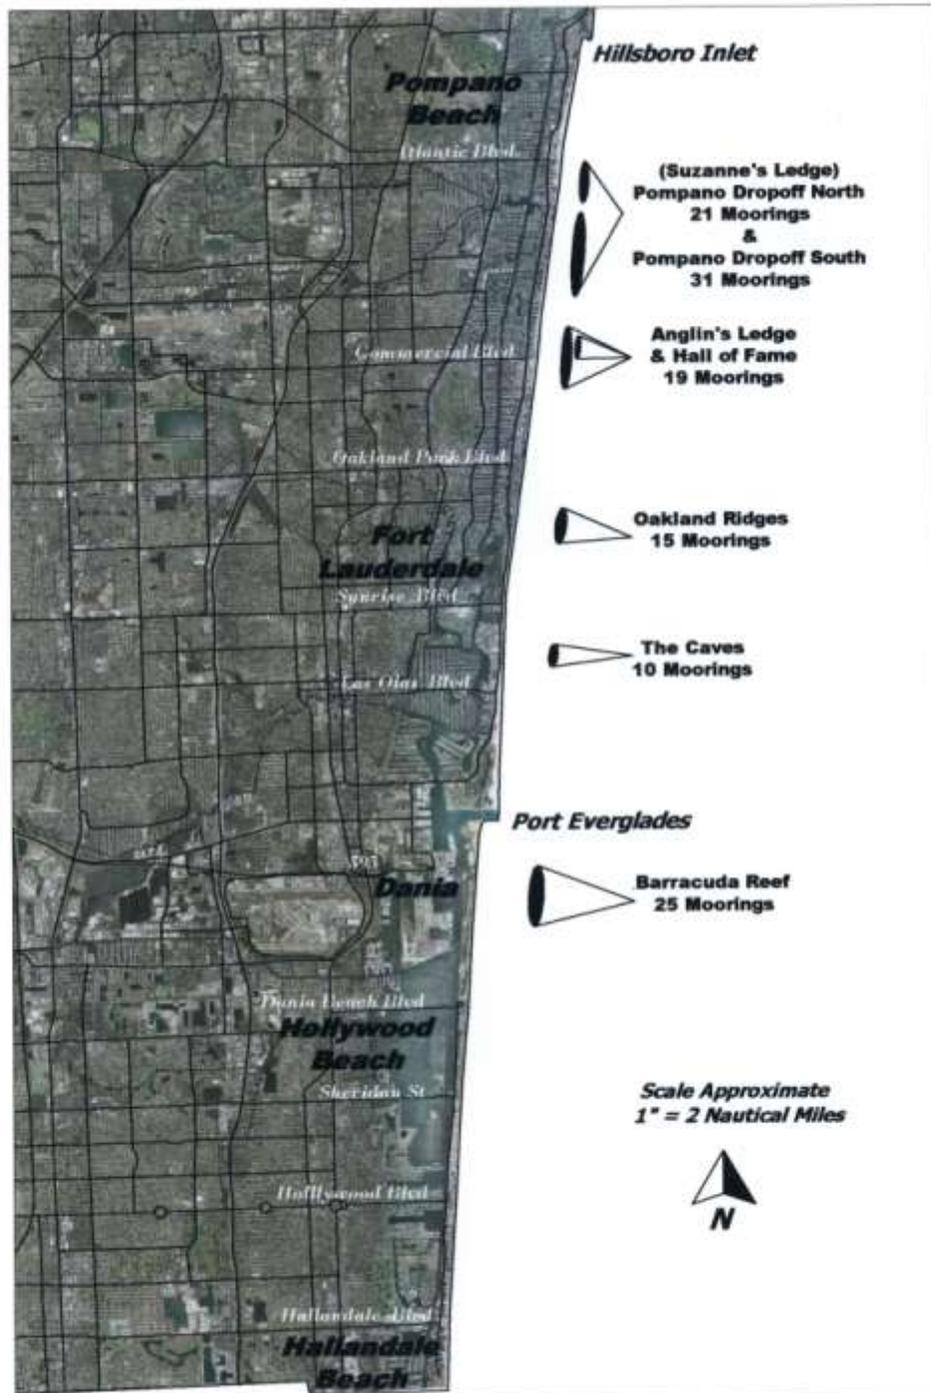
Figure 6: Broward County mooring buoy system reconfigured.

With the addition of 21 new buoys at Suzanne’s Ledge, Broward County had proposed to expand the Broward County mooring buoy system to 143 moorings. However, with the information gained during the mooring buoy use surveys, showing a boater preference towards certain mooring buoy locations, it was reasoned that eliminating the buoys at the Hollywood Beach Mitigation Reefs and reducing the number of moorings at Anglin’s Ledge would be a cost-effective modification to the mooring buoy program. This change reduced maintenance costs, yet still provided reef-protecting benefits in high use areas where protection was needed most. Broward County continues to manage a mooring buoy system consisting of 122 buoys, which are better located to protect the reefs from anchor damage (Figure 6).

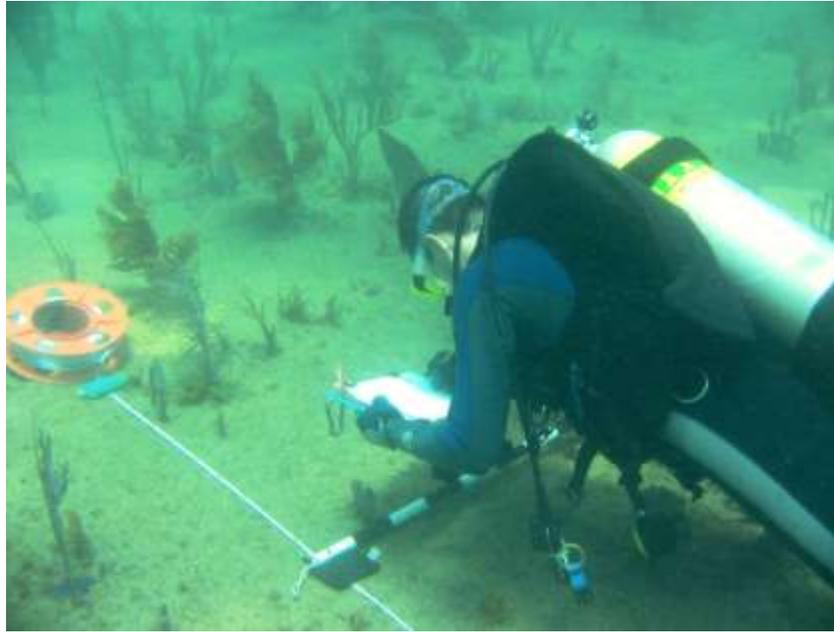
Figure 7: Volunteer diver performing a radial transect.

Marine biologists from Coastal Planning and Engineering Inc. volunteered their services and helped perform the radial transect work at Suzanne’s Ledge (Figure 7). The radial transects were performed in May 2008 prior to installing the buoys and then repeated in November 2008, approximately 6 months after the new buoys had been in place. Transects were run at four mooring buoy sites: #5, #11, #15 and #21 (Figure 9). At each location, five 25-meter x 2-meter transects were surveyed. The transects extended from each mooring buoy anchor like spokes of a wheel, at a heading interval of 45⁰, starting at 180⁰ and ending at 0⁰. Each transect covered an area 50 m² with a total of 250 m² evaluated at each buoy site.

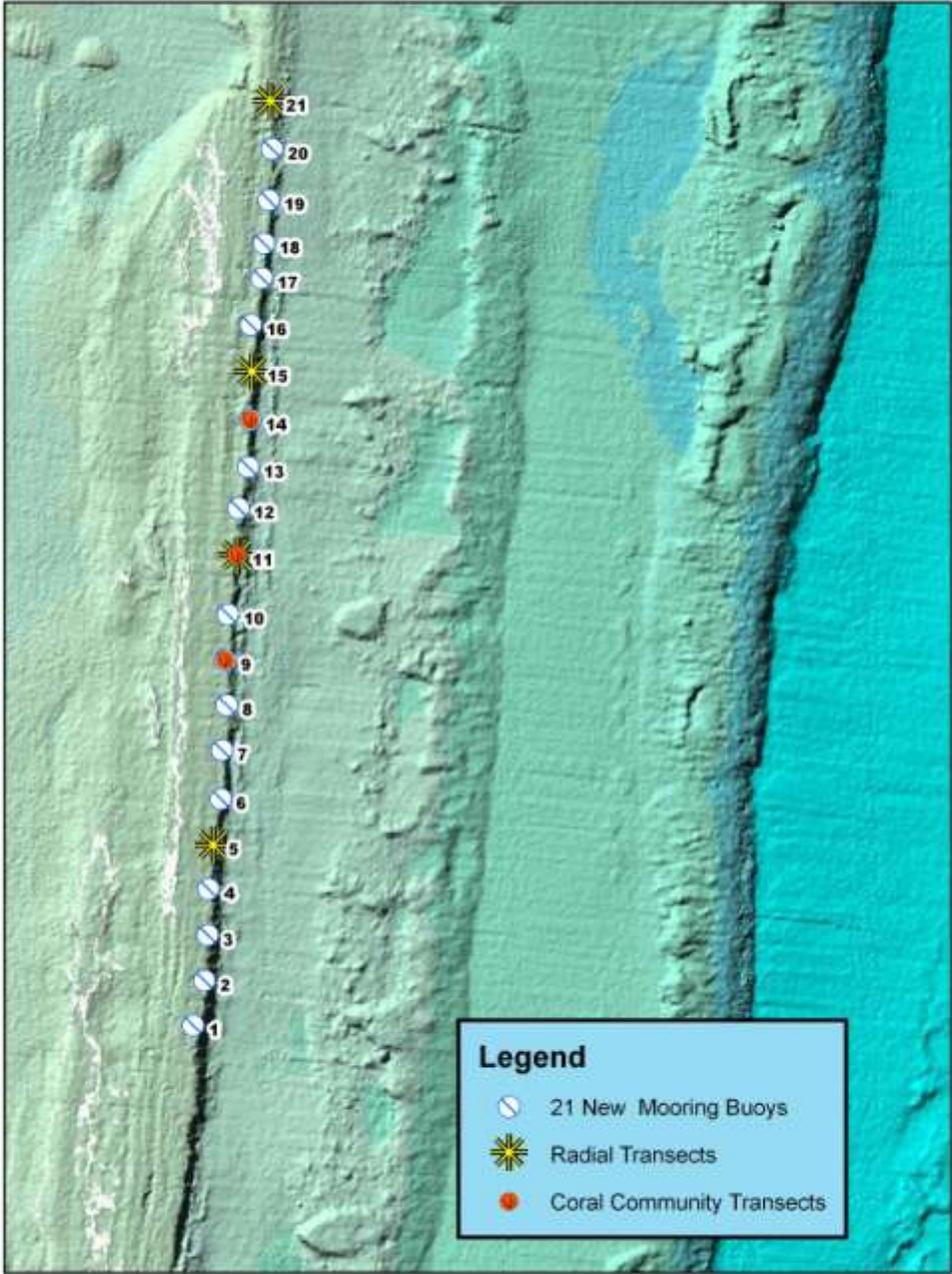
Suzanne's Ledge (Pompano Drop-Off North)
Mooring Buoy and Transect Locations
NFWF (FL) 2007-0083-002

Figure 9: Mooring buoy and transect locations.

In December of 2008 coral community transects were conducted by Broward County staff marine biologists (Figure 10). Data were collected at 3 mooring buoy locations: # 9, # 11, and #14, that were previously surveyed by the Nova Southeastern University Oceanographic Center in 2006 (Klink, 2007) (Figure 9). At each location, divers assessed a single 20-meter x 1.5-meter belt transect. Field data collection was designed to permit the following analyses for each site:

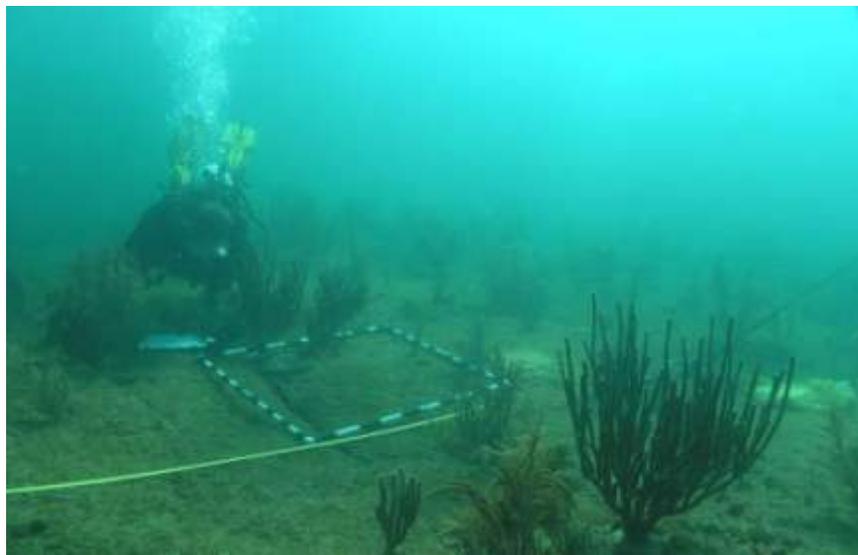
Figure 10: Broward County marine biologist conducting a coral community transect.

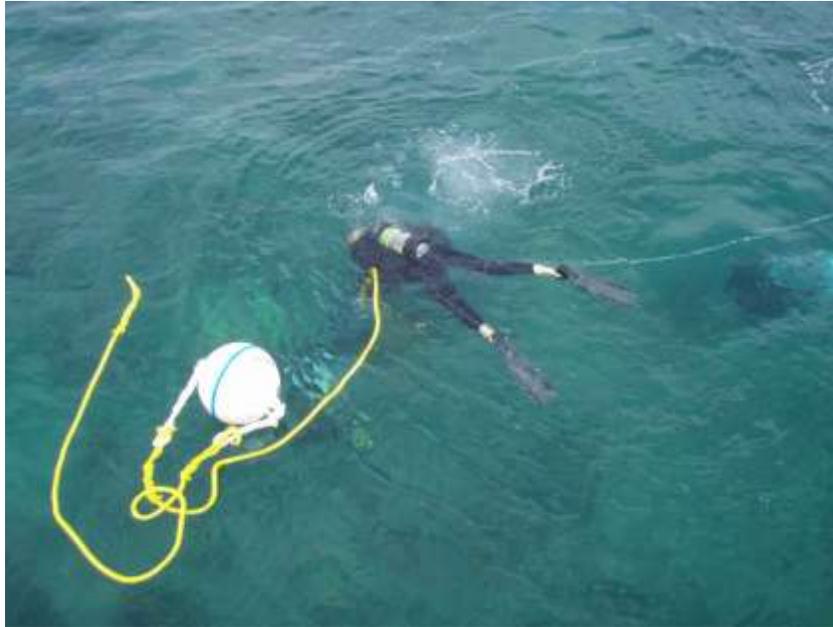
Volunteer divers installing new mooring buoys at Suzanne's Ledge.

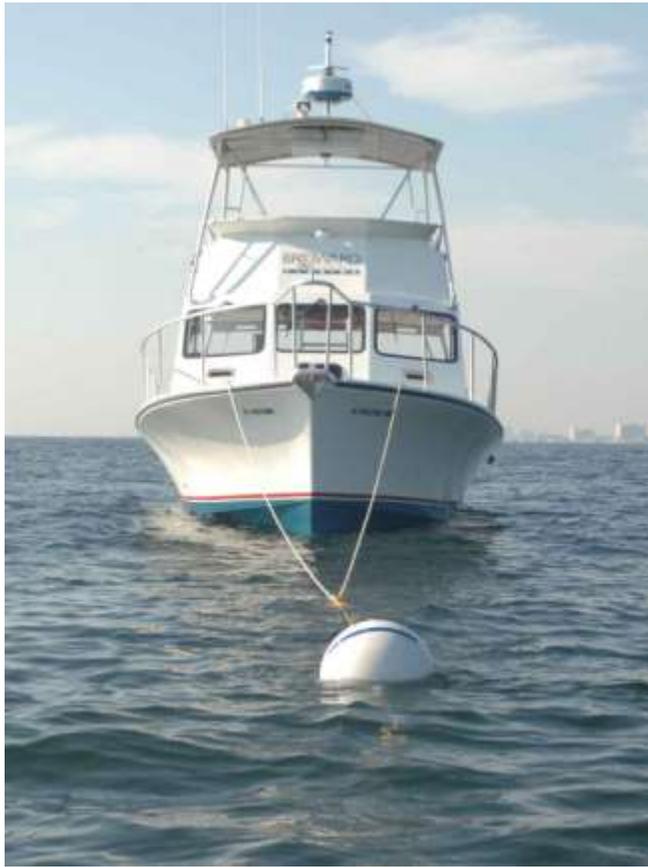
Vessel moored properly.

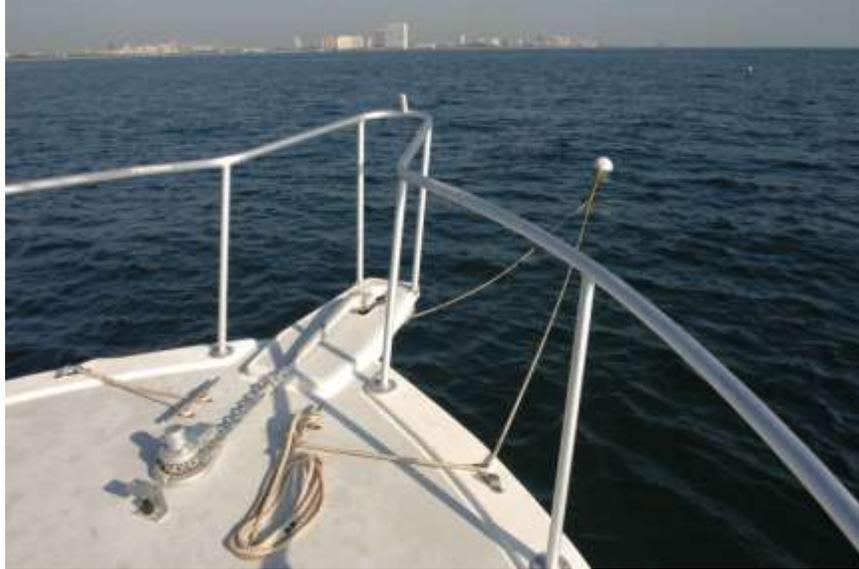
Vessel moored properly.
